# B22AeroPower B25AeroPower

Bollettino di servizio Service Bulletin S-001 MANDATORY Whirlwind propeller

# 1.4) Subject

Check the tightness of gear cover cap screws, toque setting M8 20/22 Nm

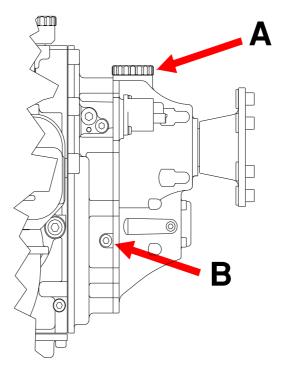
Figure 1

- **a.** be sure that the engine is horizontal position
- **b.** unscrew the gear oil filler cap (A) as shown in figure 1

- **C.** visually check the oil level in the gear box
- **d.** loosen the oil level bolt (B) on check the oil as show in figure 1
- **e.** unscrew the bolt (B) until you see a leak of oil that should increase if you keep unscrew the cup (B)
- **f.** if the is no leak of even when the bolt (B) is completely unscrew, replace the cup in the hole and refill the gearbox as explain in the Manual A (installation manual) chapter A.15.4. writing down the quantity of oil necessary to fill the gear box to the correct level. Proceed with the all following steps up to 3.5 included.
- **g.** if you have notice a leak of oil tight the cap (A) and (B) and proceed to the following step 3.3

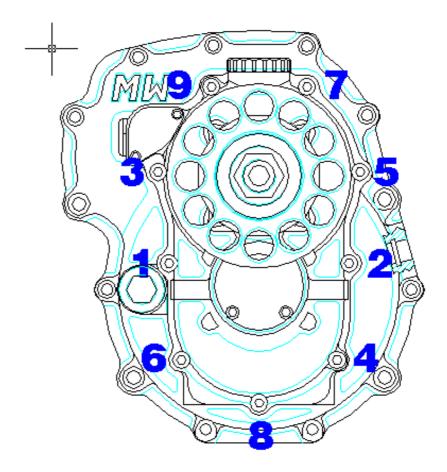
Figure 2

- **a.** set the torque wrench at 22Nm
- **b.** try to tighten each M8 bolt, show in figure 2, and verify that the torque wrench indicates the proper torque value without the bolt rotating.

- **c.** if the torque wrench does not release immediately indicating that the torque value is correct, but instead the bolt rotates substantially before reaching the correct torque value, write down of the rotation done for each bolt and proceed with the following steps up to 3.5 included
- **d.** if all the bolt are correctly tight proceed to the following step 3.4
